Manhole Inspection Summary

Manhole # S35CC1009MH

Insp Date: **12/7/06 11:50 AM**

Location Address: **306 SUFFOLK RD**

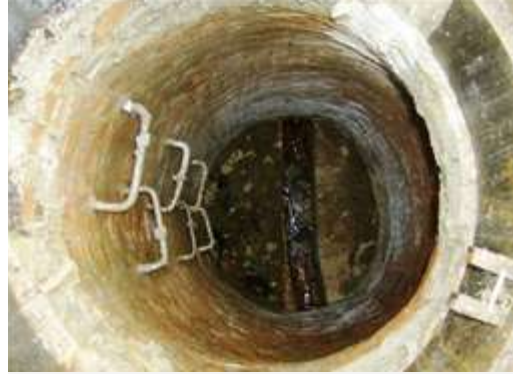
Top View

Evidence of surcharge - Bench debris.
Channel debris.

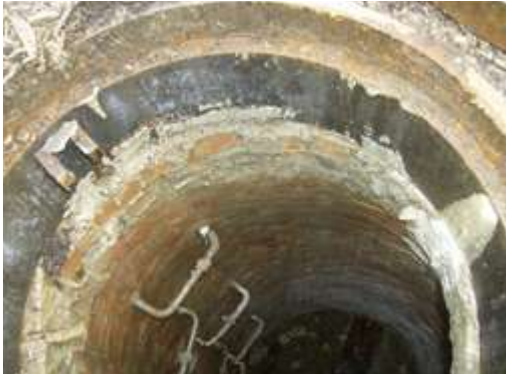
Defect

Frame leaks. Adjustment, Corbel and
Barrel infiltration.

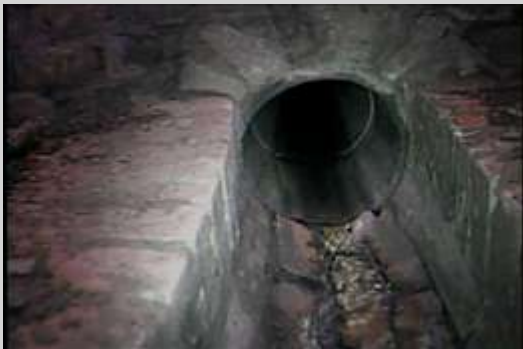
8 in. Circular Gravity Sewer Pipe In @ 5 O'Clock

Infiltration: **Evidence** Pipe Seal Cond: **Unknown**
